Proof of Performance Test Report

MANTIS

April 2005

**Proof of Performance Test Report
on
Mine Clearing/Survivable Vehicle
(Mantis)**

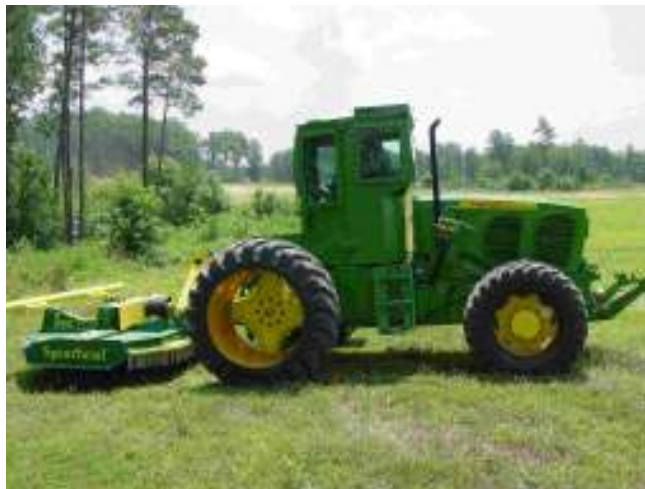
Figure 1: Mine Clearing/Survivable Vehicle (MCSV) with Rotary Mower

The MCSV is a modified and armored John Deere 6920 farm tractor capable of operating a number of specialized and off-the-shelf commercial implements to address some of the vegetation clearing, soil preparation, area reduction, quality assurance, and mine removal and neutralization problems in humanitarian demining operations. The system is equipped with front and rear power take-offs (PTO), standard three-point hitches front and rear, and a modified loader frame. The tractor was modified, armored, and reassembled by *Pearson Engineering Ltd.*, Newcastle upon Tyne, England, under contract to the US Army NVESD.

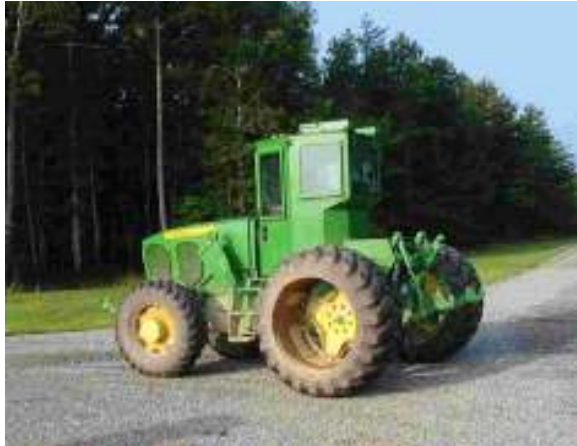
Figure 2: Mine Survivable Tractor

The intent of the MCSV is to provide a mine-survivable vehicle based on a commercial off-the-shelf (COTS) farm tractor. This tractor has been armored, fitted with a rotating driver's cab and antipersonnel (AP) mine survivable SETCO wheels with an innovative wheel hub interface incorporating a dowel and plate design. This design allows the wheel to separate from the axle in the event of an antitank (AT) mine detonation, thus reducing the shock effect through the axle and the tractor body to the operator. The SETCO wheels are also a commercial product. This vehicle is to act as the prime mover for a toolbox of COTS and specialized implements generally used by construction and earth-moving industries. Along with the mine resistant John Deere tractor, this toolbox currently consists of:

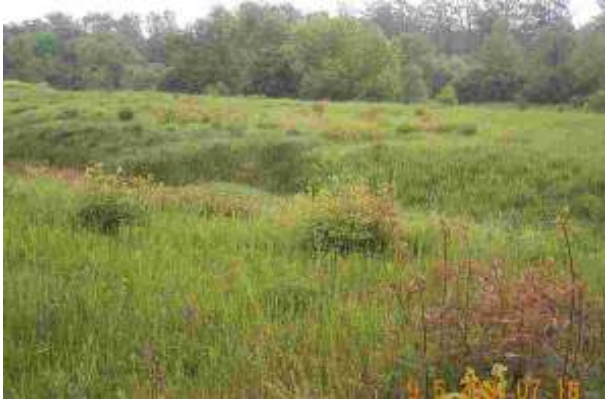
Figure 15: Category 1, Easy

All four vegetation categories were represented at the test site and are shown below in Figure 15 through Figure 18. Table 3 gives definitions of each category.

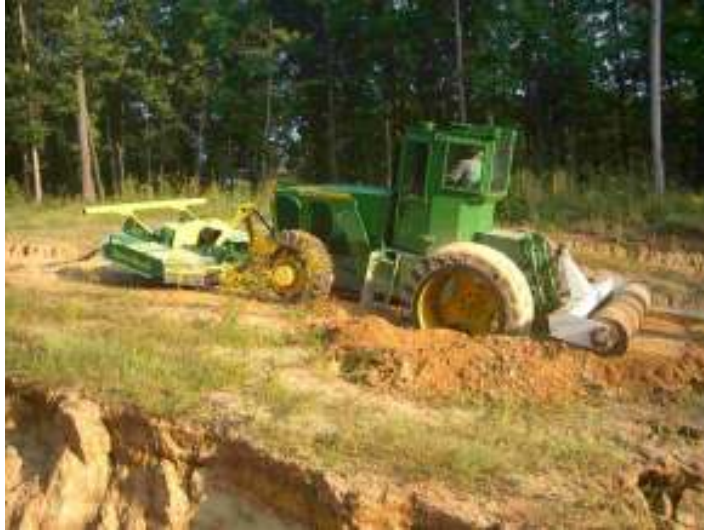
The MCSV, with SETCO tires and the rotary mower and area reduction roller mounted, got stuck on a section of the cross-country track that approximated a 20-degree slope in soft, damp sand. Getting stuck appeared to be caused by a combination of the rigidity of the solid tires and the molded traction cleats in the rear tires, which are close together, becoming packed solid with soil. This resulted in the rear, heavily cleated tires taking on the characteristics of “slick” tires, with no flexibility to self-clean (see Figure 19). The tractor was able to back out of the ruts, created in its attempt to go forward, after sections of logs were placed into the ruts behind the four driving wheels. A dozer was brought in to repair the damage done to the dirt road over the length of the hill

Figure 19: MCSV Stuck in Damp Sand Hill

Two days later, after the soil had a chance to drain, the run was made again with SETCO tires and the counterweight and area reduction roller attached. There were no problems and not a single hesitation or wheel spin when the MCSV climbed the portion of the hill where it had previously gotten stuck. The run was completed at an average speed of 8.97 mph (14.5 kph).

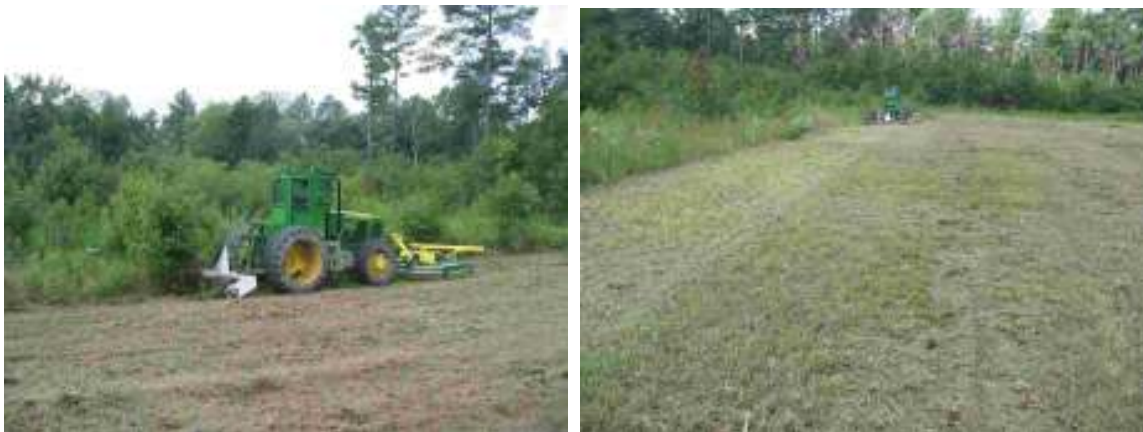
To demonstrate using the mower in an AP mined area, and to eliminate clutch disengagements in heavy Category 2 vegetation, the mower was used in tandem with the area reduction roller. On the first pass through a Category 2 vegetation area, the roller was pushed through the vegetation (cab facing to the rear and roller mounted on the rear), with the mower following and raised about 6 to 12 inches (15 to 30 cm) off the ground. At the end of the pass, the MCSV operator rotated the cab, dropped the mower to ground level, and retraced the path he had just taken, this time with the mower leading and the roller following. While this double-pass operation increased the mowing time, it resulted in a closer cut area and minimized the chance of the mower deck being caught on dirt or shrub growth, causing shaft damage as described above.

Figures 20 and 21 show the results of mowing with the use of the roller, and of the sheared universal joint (drive shaft yoke).

Figure 20: Area Reduction Roller and Mower Results

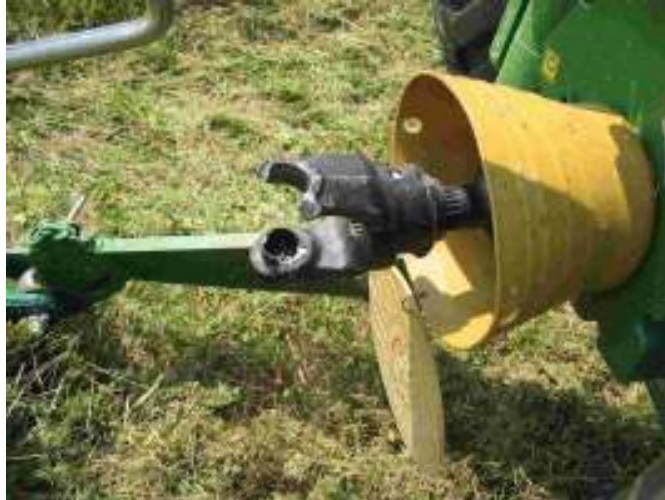
When bringing, or more accurately, dropping the rotary mower down on thick clumps of Category 2 vegetation stubble, which were frequently accompanied with local ground heaving caused by a dense root system, the high peak loads on the mower drive train caused the PTO clutch to disengage. When this happens, this procedure is followed:

One such encounter caused the universal joint on the tractor end of the PTO shaft to shear. In this case, the mower was mounted on the front of the tractor, and the tractor was backing down a mowing lane, pulling the mower. The rear of the mower (side closest to the tractor) dug into the ground, causing the front of the mower deck to rise. This put the drive shaft into a bind while under power, which caused the universal joint (drive shaft yoke) to break. Parts were obtained from the local John Deere dealer, and the test continued on the following day.

Figure 21: Sheared Universal Joint

The prime mover, a commercial John Deere 6920 tractor, has a proven history of reliability and is supported by a worldwide network of commercial dealer organizations. The tools are off-the-shelf and commercially available, with spare parts support direct from manufacturers and dealers. During the performance demonstration, there was not a single unscheduled maintenance incident on either the tractor or any of the tools. The one repair to the tractor, the fuel tank leak, was caused by a change in design during manufacturing and resulted in the rework of a single item. The need for this rework will not be necessary on subsequent vehicles, thus eliminating the possibility of it happening again. The shearing of the PTO universal joint was the result of inexperience with the system and the tool.

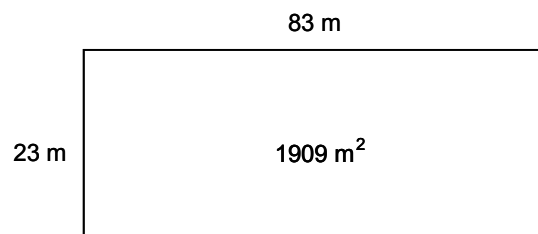
Two timed mowing tests were conducted to provide planning factors for field operations of the rotary mower. The first test was with the mower only on an area where the vegetation progressed from a heavy Category 1 to a mix of Categories 1 and 2. The area mowed was 1,909 m², the time required was 62 minutes. This equates to approximately 1,850 m² per hour. Figure 22 is a diagram of the mowed area.

Figure 22: Mowed Area (1900 m²/h), Mower Only, Single Pass

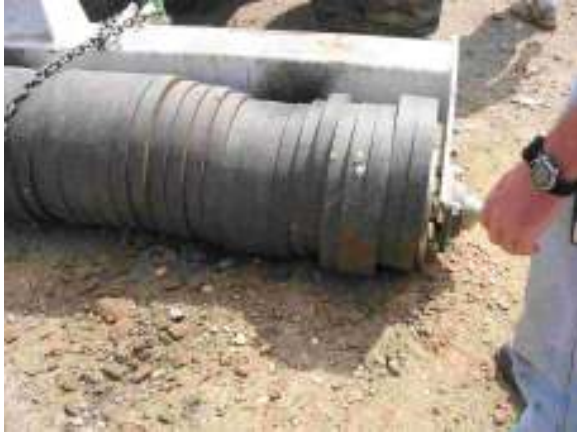
Blast tests were also conducted against the roller. The explosive, designed to simulate a heavy AP mine, consisted of ½ pound of TNT initiated by a small U.S. AP mine. Three explosive charges were laid with the initiator mine's detonator just above the surface. The tractor, with the roller attached on the front, was pulled over each of the explosive devices. The roller sustained no damage. See Figure 23.

Figure 23: Results of Blast Test Against Roller

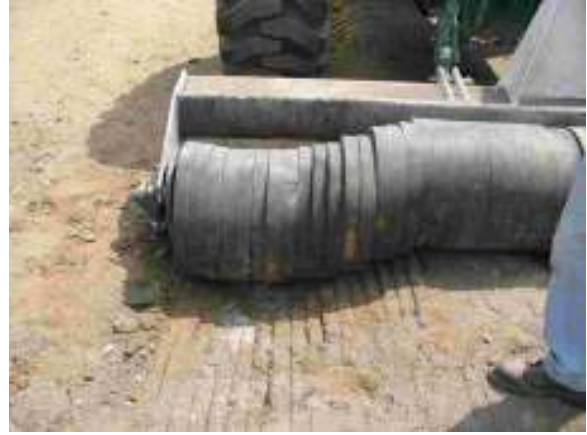
In Lane 1, 80% of the flush-buried mines were detonated. All those not detonated were Type-72A MRMs. In Lane 2, 75% of the mines were detonated. Those not detonated were eight Type-72A and two PMA-2 MRMs.

Figure 24: Test Lane Configuration and Mine Emplacement

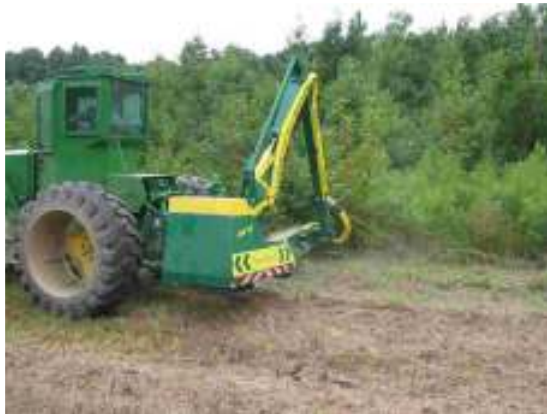
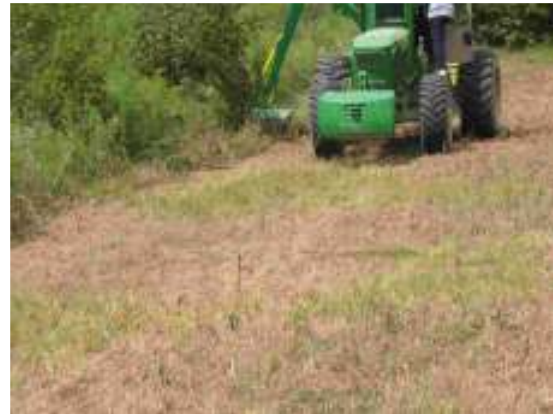
The Hedge Trimmer, designed to be mounted on the rear 3-point hitch of the tractor, is powered by the rear PTO. The PTO drives an on-board hydraulic system that controls the movement of the boom and powers the cutter head. The boom allows the hedge cutter to operate over an intervening guard rail or other similar obstacle and cut the vegetation beyond

the obstacle. The cutter is powerful, quiet, with very minimal vibration, indicating excellent balance of the cutting rotor. The cutting rotor has a double row of cutters with 14 cutters per row. The cutting swath is 1 meter. With the boom fully extended, and with no intervening obstacle, the cutting head is able to reach out 13.33 ft (4 m). The Hedge Cutter had no problem cutting Category 1 and 2 vegetation. On Category 3 vegetation, the cutter was able to cut the vegetation down to ground level only by cutting the vegetation in stages, beginning at the top, and working down. The Hedge Cutter was not designed to be operated in this fashion; however, it can be done, albeit awkwardly. The Hedge Cutter appears to be sufficiently robust to operate for extended periods of time against Categories 1 and 2 vegetation. No trials of area versus time were made. No mechanical problems were encountered.

Figure 25: Brush Cutter Operations

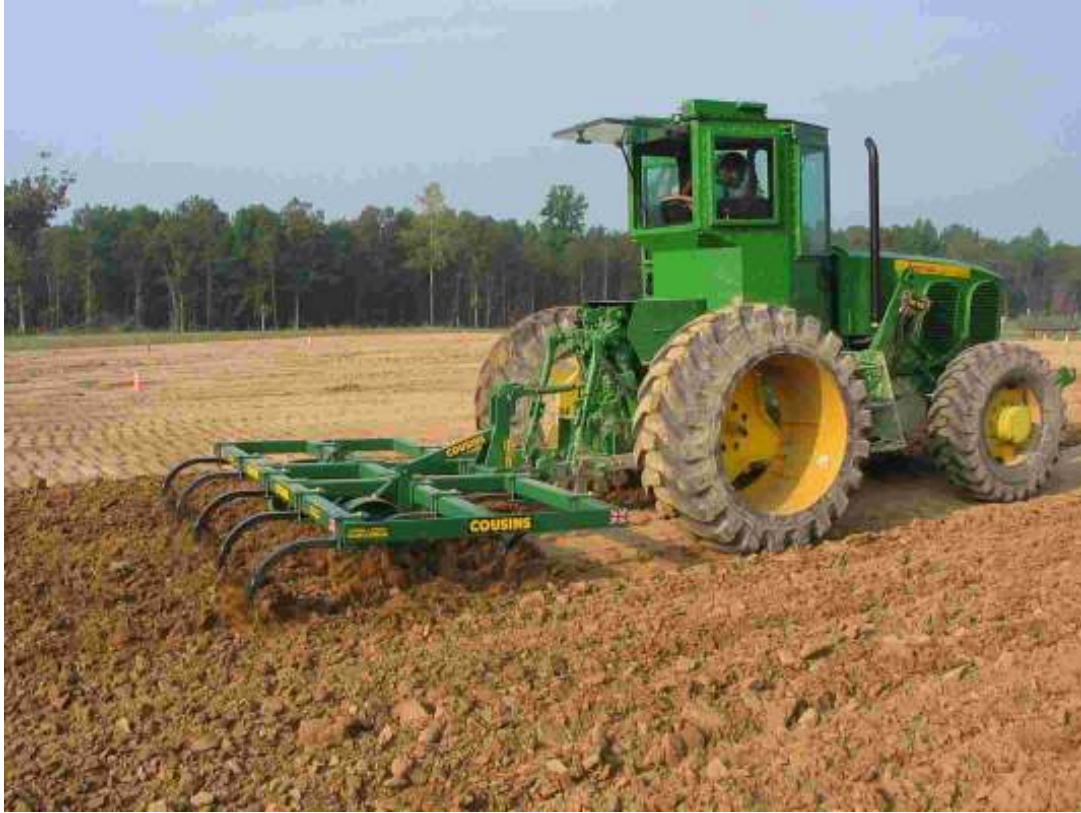
The Spring Tine Cultivator, a commercial farming tool, was mounted on the MCSV with SETCO tires. The test area was hard-packed sandy clay soil. At the start of the test, when the MCSV operator tried to control the tractor throttle and depth of the cultivator manually, the cultivator operating depth varied as the surface of the field rose and fell, and the MCSV was brought to a complete standstill at low tractor speeds by the drag of the cultivator. However, when the tractor was put into Economy Drive (similar to cruise control), the cultivator allowed to ride on the depth-control wheels installed on the cultivator, and the desired tractor speed set, the MCSV fuel-control system and engine computer automatically adjusted the fuel flow to keep the tractor moving as the cultivator load on the tractor varied. When driven using Economy Drive, the tractor was able to cultivate the soil to a depth of 6 inches (15.25 cm) on all three rows of tines. No time trial measurements against area cultivated were made.

Figure 26: Spring Tine Cultivator Demonstration

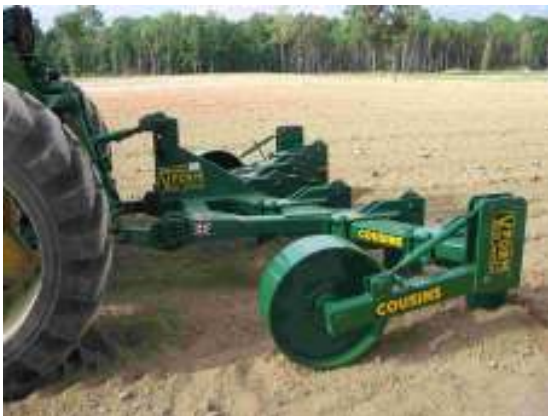
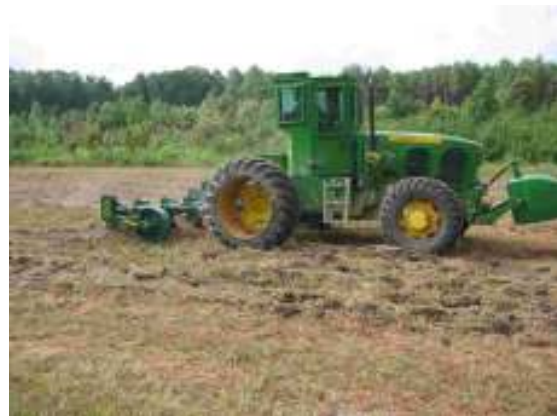
Based on the experience with the Spring Tine Cultivator, the performance test of the Soil Loosener made use of the installed depth-control wheels to control the tool's operating depth, and the Economy Drive system was engaged. Trials were conducted in dry, compacted sandy clay soil with no vegetation and in an area where Category 1 vegetation had been cut with the rotary mower. At both sites, the MCSV had no trouble pulling the Soil Loosener at an operating depth of approximately ½ meter.

Figure 27: Soil Loosener in Packed Clay and Heavy Sod

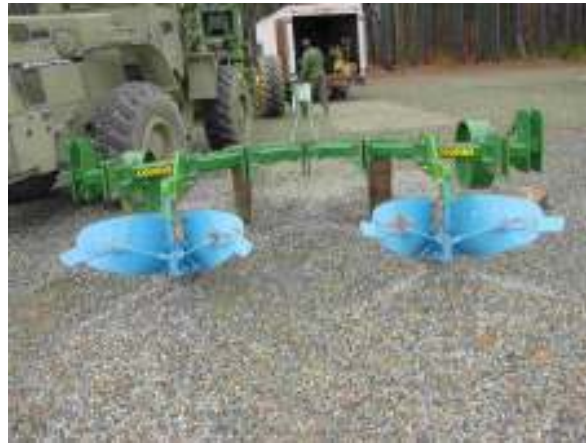
The Bed Formers were installed on the Soil Loosener frame once the Soil Loosener blades were removed. The two Bed Formers are shaped like plows and are so spaced that the distance between their center points is equal to the tire track width of both the MCSV and the Soil Sifter. The Bed Formers, capable of operating up to a depth of 14 inches (35.6 cm), move the broken-up soil (preprocessed by the Soil Loosener) into windrows measuring 7.48 feet (2.28 meters) wide from the center of one trough to the next. SETCO tires can also be mounted on the MCSV without the blast-off mounting hub.

Figure 28: Bed Formers Installed on the Soil Loosener Frame

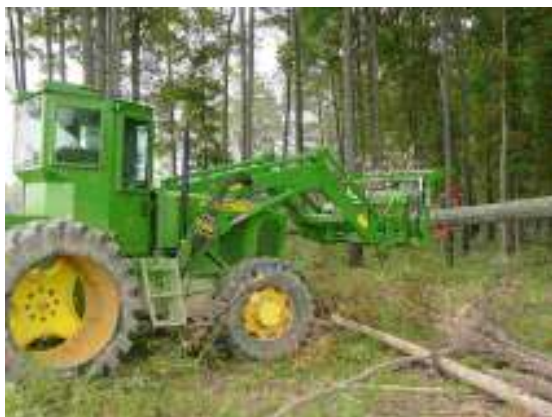
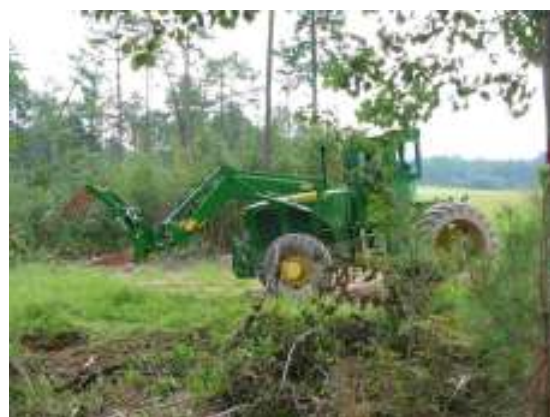
The Grab, designed to pick up cut brush, debris from forestry operations, or any loose material resulting from a vegetation-clearing project, is mounted to the tractor using the Universal Mount. Although operator visibility of the tool is limited when the tool is on the ground, with a minimal amount of experience the operator is able to use the tool with no trouble. As can be seen, lifting capacity, by weight, is sufficient to handle large debris-clearing jobs. No tests, other than the demonstration shown, were conducted.

Figure 29: MCSV with Grab

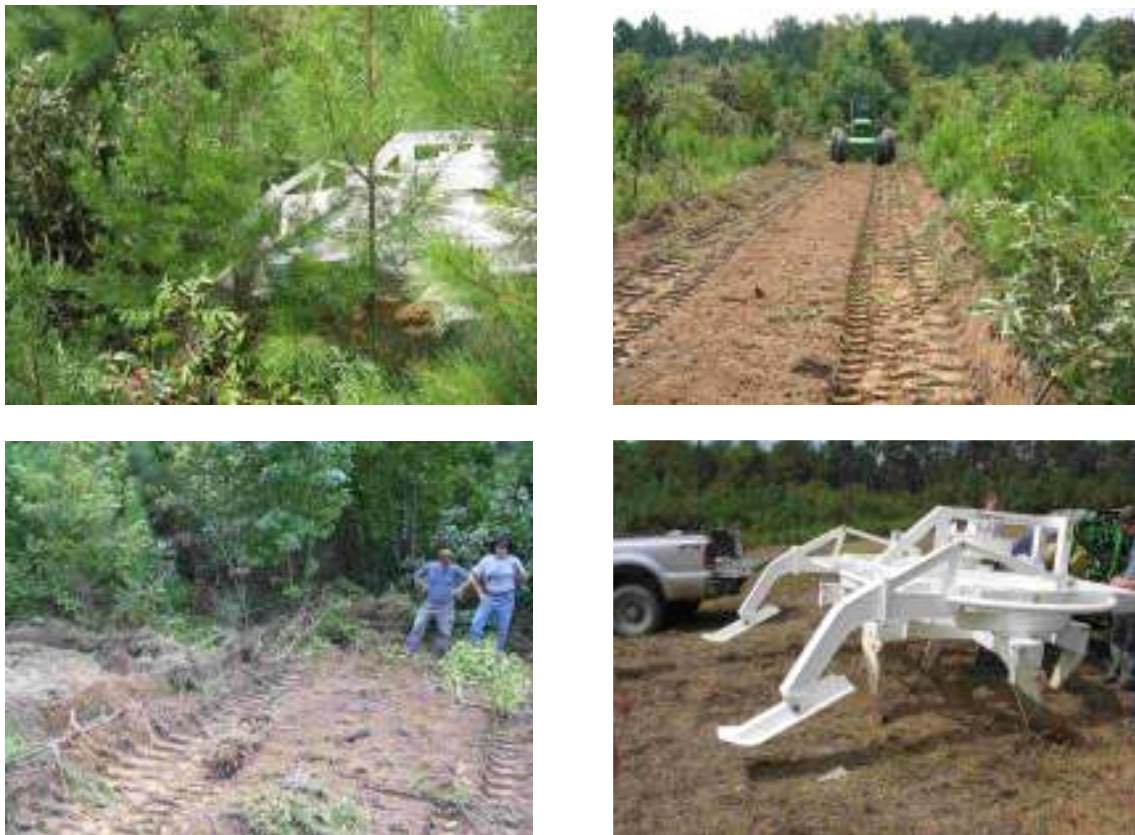
The Rotary Mine Comb, designed and built by Pearson Engineering, Ltd., is an adaptation of an old idea for a garden tiller. The two sets of counter-rotating tillers, canted slightly outward, bring mines to the surface and then slowly, and gently, move the mines to the sides of the tiller and deposits them in windrows. Throughout the demonstration, the Rotary Mine Comb handled all vegetation conditions, ranging from dense Category 1 to very heavy Category 3, with ease. The 40 cm operating depth of the cultivating tines removed not only the above ground vegetation, including 15 to 20 ft (4.6 to 6.1 meter) tall trees up to 3 inches (7.6 cm) in diameter, but also dug up the trees' root systems. This tool, without exception, was the best area-proofing and mine-removal tool tested during the MCSV proof of performance. Pictures showing the Rotary Mine Comb in action and the results of its operation are shown in Figure 30.

Figure 30: Rotary Mine Comb Demonstration

During the performance demonstration in heavy Category 2 and Category 3 vegetation, the operator had trouble steering in a straight line with the mine comb pulling the tractor on a gentle curve to the left. If the ground is not level, the Rotary Mine Comb digs more deeply on the low side. This in turn exerts a pull to that side causing the tractor to

An operational transit problem presented itself and a workable solution was devised. In the full-up position with the Rotary Mine Comb out of the ground and the PTO shaft connected to the Rotary Mine Comb, the Rotary Mine Comb clears the ground by scant inches. When moving from a staging area to a work site over anything other than a flat, smooth surface, the Rotary Mine Comb digs into the ground as the MCSV pitches and sways over the uneven surface. Since the PTO shaft is the limiting link in determining ground clearance in the all-up position, it is recommended that the PTO shaft not be connected until the Rotary Mine Comb is at the work site. This allows additional ground clearance when in the all-up position. When departing a work site, the PTO shaft should be disconnected.

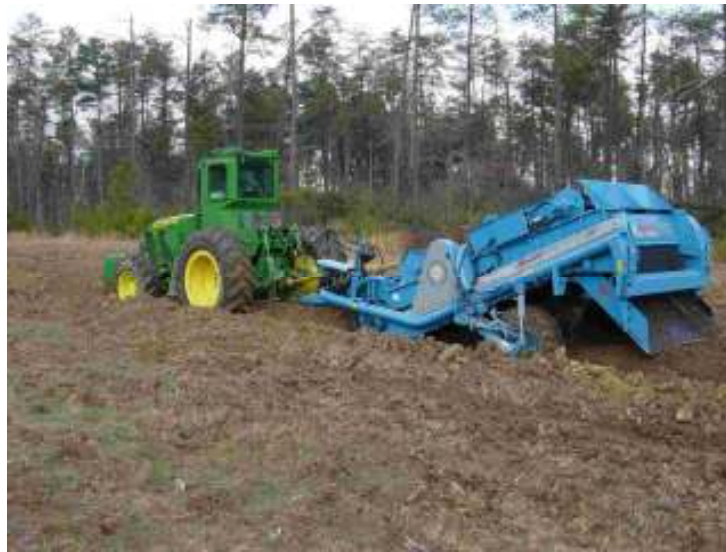
at the rear of the sifter. Experience showed that the sifter was much more efficient when operated at the lower of the PTO speeds (540 rpm vs. 1000 rpm). At a forward speed of 1 mph (1.61 kph), the sifter is capable of sifting 3,033 square yards per hour (2,773 square meters per hour).

There are four drawbacks to using this attachment, one potentially serious, three easily correctable. The serious drawback is that the MCSV would have to drive over a mined area to prepare the soil with the Soil Loosener and Bed Formers prior to using the Mine Sifter. The second drawback involves the rear-facing chute. Because of its width, mines can be deposited in the trough between the sifted windrows and might be covered with a thin layer of soil that slides down the sides of the sifted windrows. This can pose a hazard to deminers who would walk in the troughs looking to recover sifted mines. An easy correction to keep the mines on top of the sifted windrow is to install a choke in the discharge chute, ensuring that the mines are deposited in the center portion of the windrows. The third drawback is that the MCSV operator cannot see what is being deposited by the rear facing discharge chute, and therefore alert waiting deminers of a sifted AP mine. It is thought that an observer using binoculars should be able to spot sifted mines. Finally, SETCO tires with standard hubs, and not the blast-off hubs, have to be used to match the tire track width of the sifter.

Figure 31: Mine Sifter in Operation

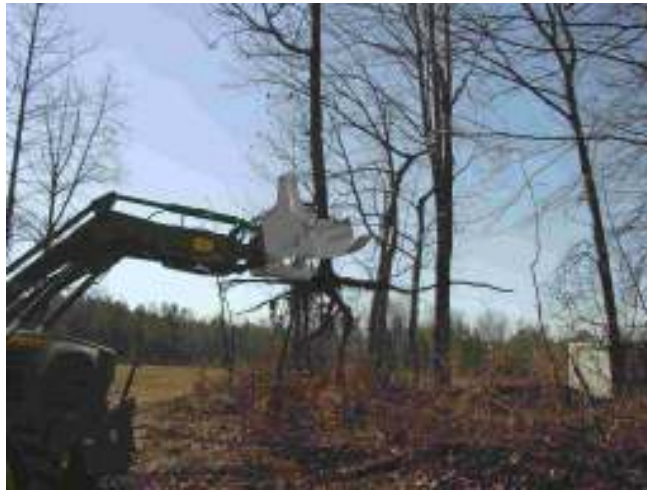
The Tree Picker, also supplied by Pearson Engineering, Ltd., is a hydraulically actuated attachment that mounts to the MCSV using the standard 3-point hitch on the front of the vehicle. The picker is actuated by two electronically controlled hydraulic feed lines off the MCSV's hydraulic system, mounted one on each side of the 3-point hitch. These operate the left and right power outriggers on the picker as well as the central tree-grabbing mechanism. Limited training on and use of, the tree picker occurred during the assessment. However, the demonstration did include the removal of a 12 inch (30.5 cm) diameter tree well in excess of 60 feet tall.

Figure 32: Tree Picker in Operation

Two operational issues were noticed during the demonstration assessment, which included using pneumatic tires on the MCSV. The first is that the pressure placed on the front tires during the tree extraction process and later by the weight of the extracted tree was sufficient to almost totally collapse the front tires. Therefore, it is recommended that the tree picker be used with the SETCO tires installed on the MCSV. The second is that forward moment caused by the weight of the extracted tree made the MCSV very light on its rear tires. Therefore, any extracted tree should be lifted slowly to make sure that the weight of the tree does not cause the rear wheels to lift off of the ground.

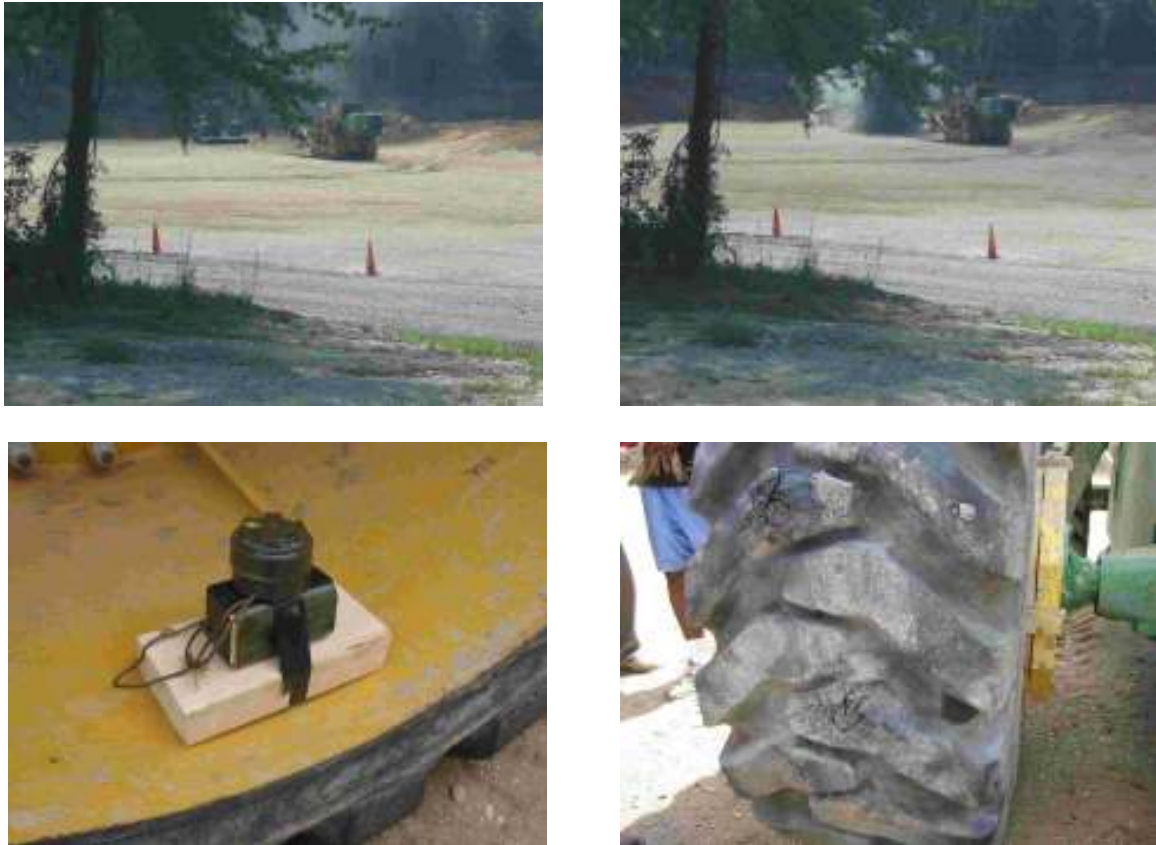
Two blast tests were conducted against the left rear SETCO tire. The two explosive charges used were (1) $\frac{1}{4}$ pound TNT initiated by a small U.S. AP mine, and (2) $\frac{1}{2}$ pound TNT initiated by a small US AP mine. The explosives were buried with the AP mine pressure plate at ground level. The SETCO tires sustained some surface scuffing and localized charring from the blasts. While there was more surface scuffing caused by the $\frac{1}{2}$ pound explosive charge, neither blast area showed significant damage. Given the size and the surface area of the tires, each tire could probably sustain hundreds of such blasts before consideration might be given to changing them.

Figure 33: Blast Test, SETCO Tires

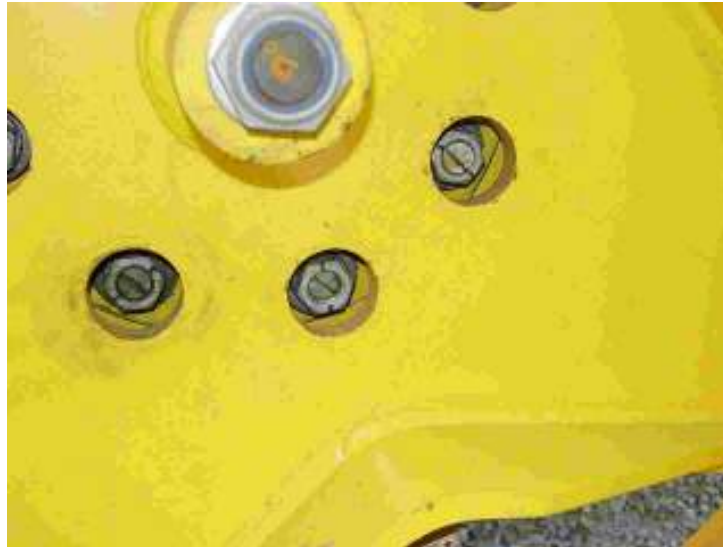
- g. Lapsed time for the repair was 8 hours, with one to three people working at all times.
9. It was noticed during the inspection of the MCSV, after the on- and off-road mobility trials, that the wheel lugs on the rear SETCO tires had worked loose. The lugs nuts were tightened and the trials made with the heavy cultivator. Inspection of the lug nuts showed that they had again become loose, some as many as three and four complete turns of the nut. The nuts were again tightened, using a large breaker bar with a 4-foot extension pipe. The lug bolts were marked and checked three to four times a day for the remainder of the demonstration. There was no further loosening of the lug nuts. See Figure 34. The offset of the black lines on the stud and lug nut indicates a loose lug nut. As can be seen, the bottom lug nut has backed-off at least three full turns.

Figure 34: Loosening Lug Nuts

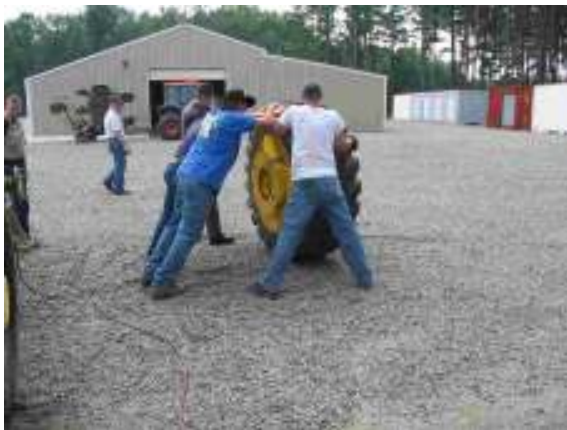
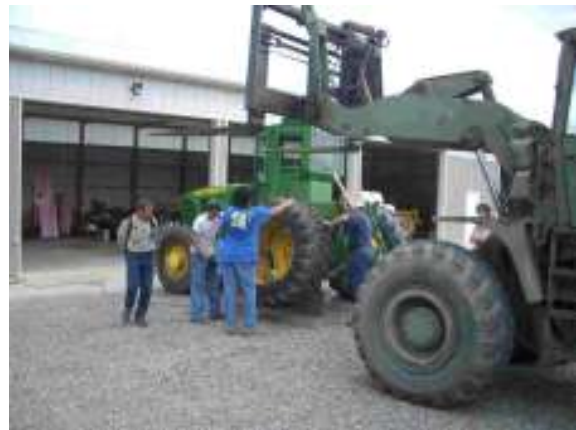
Changing of the rear SETCO tires requires some means of lifting the tires and two to three strong men to position them on the axle. During the proof of performance demonstration, a forklift was used to lift the tire into position. See Figure 35.

Figure 35: Mounting SETCO Rear Tires

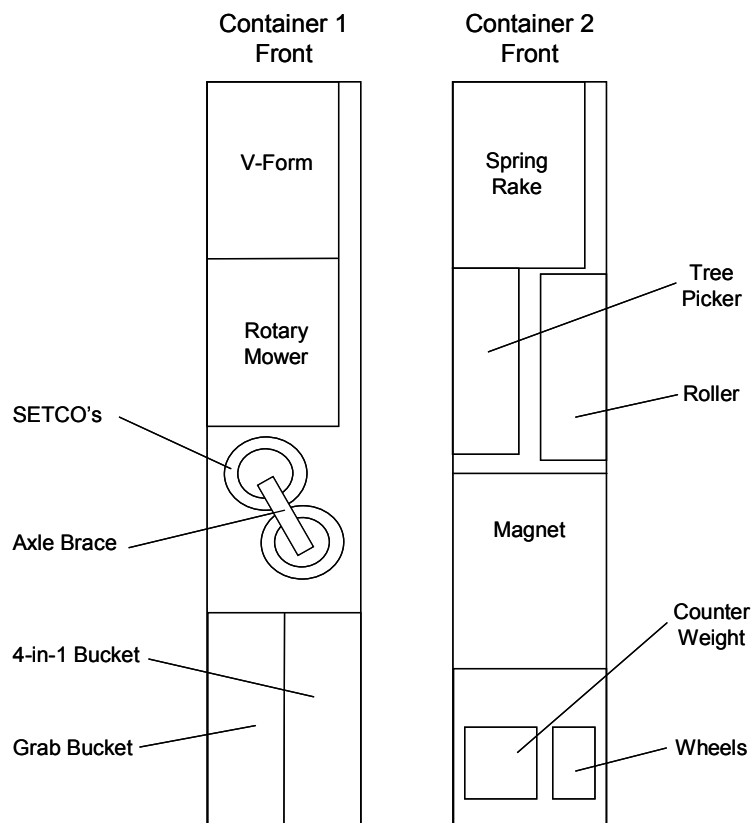
For overseas or long-distance in-country shipment, the MCSV tools and attachments will be loaded into two, 40 foot long CONEX containers according to the loading plan shown in Figure 36. The tractor will be driven into or onto a ship, flatbed rail car, or flatbed trailer and chained in place for shipment.

Figure 36: MCSV Load Plan: Two 40-foot Containers
